Home Inspection Report

1 Sample rd
Anytown, Ma 00000

Close-Up Home Inspection

10:31 July 28, 2020

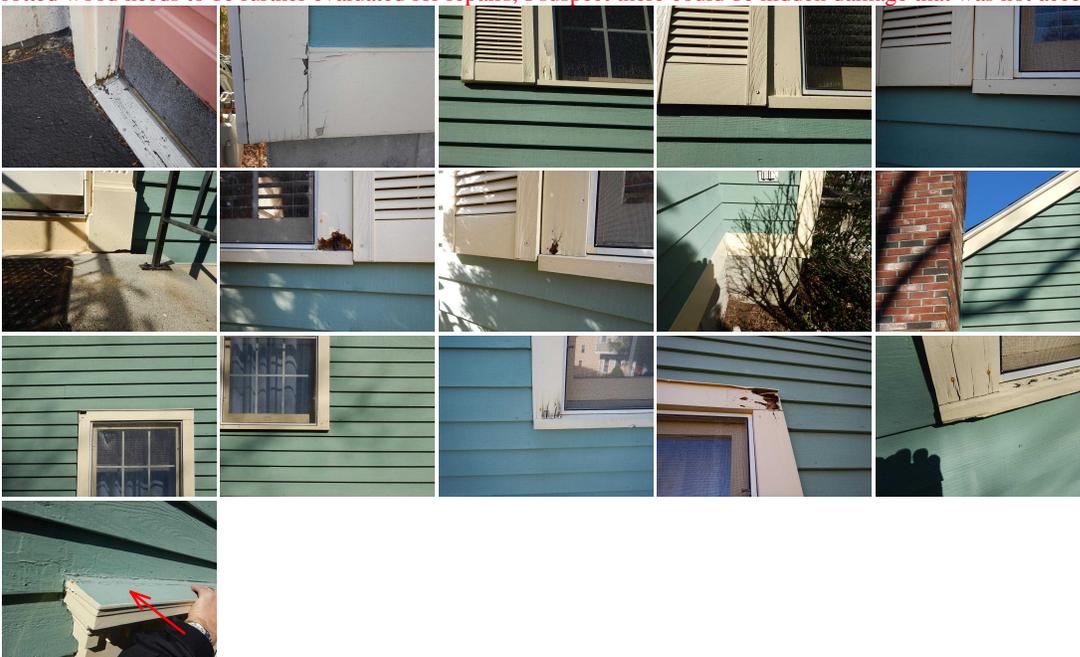
2. Trim: Wood trim paint as needed, **Need to replace the rotted trim at the front garage door entrance. Many of the windows have rotted sills and trim that needs to be replaced. The flashing at the front door trim needs to be fully flashed. Need to replace the rotted corner trim. The rotted wood needs to be further evaluated for repairs, I suspect there could be hidden damage that was not accessible.**
